WESTERN ENGINEERS & GEOLOGISTS

GEOTECHNICAL INVESTIGATION REPORT

Wyoming National Guard Facility Wheatland, WY 82201

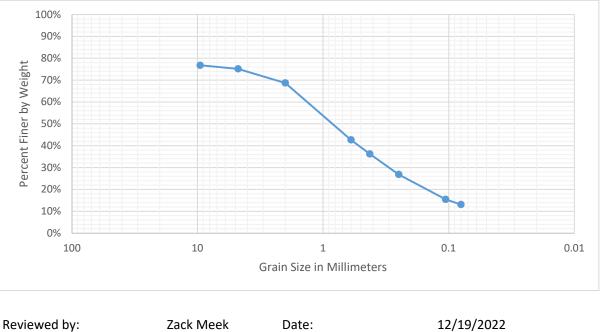
Uniformity	Coefficient	Washing			
Initial Mass:	892.2	% Moisture:	#DIV/0!	Initial Mass	892.2
Final Mass:	892.2	D10:	0.07	Mass of Pan + Soil (B)	1271.32
% Mass Lost:	0.0%	D30:	0.30	Mass of Pan + Soil (A)	1162.14
Tin:		D60:	1.50	Mass Passing 200	109.2
Tin + M _D :		C _C :	0.9		
Tin + M _w :		C _U :	21

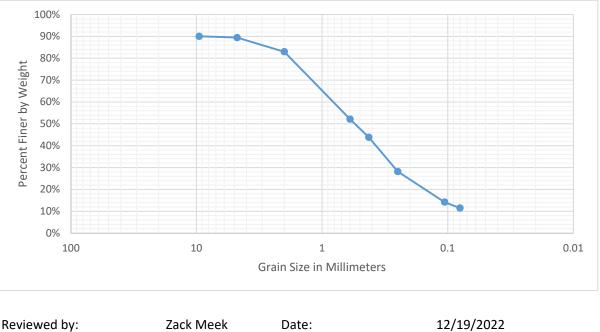
Uniformity Coefficient, Percent Moisture, and Mass Lost		Washing			
Initial Mass:	820.7	% Moisture:	#DIV/0!	Initial Mass	820.7
Final Mass:	820.7	D10:	0.08	Mass of Pan + Soil (B)	1255.75
% Mass Lost:	0.0%	D30:	0.28	Mass of Pan + Soil (A)	1170.45
Tin:		D60:	0.80	Mass Passing 200	85.3
Tin + M _D :		C _c :	1		
Tin + M _w :		C _U :	10

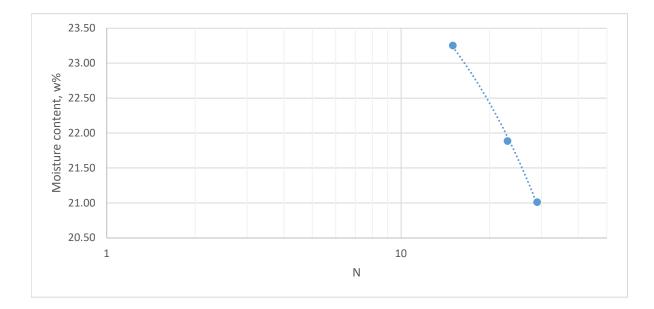
LL =	22
PI =	5

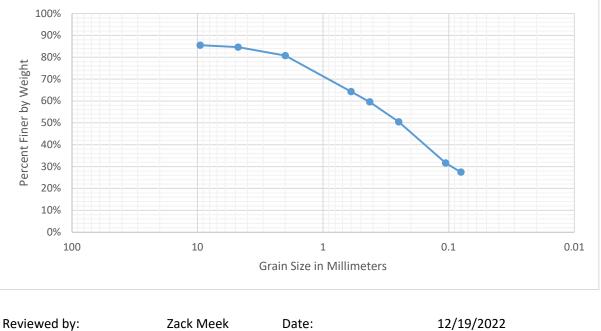
Sieve Size	Weight Retained +	Weight Retained	Percent	
Sieve Number	(mm)	Pan (gm)	(gm)	Retained	Percent Finer
0.375	9.53	742.4	68.0	14%	86%
4	4.75	678.4	4.0	15%	85%
10	2	692.7	18.3	19%	81%
30	0.6	751.5	77.1	36%	64%
40	0.425	696.6	22.2	40%	60%
60	0.25	717.1	42.7	50%	50%
140	0.106	762.7	88.3	68%	32%
200	0.08	694.0	19.6	73%	27%
Pan		680.5	128.8	100%	0%
		Total	469.0

Uniformity Coefficient, Percent Moisture, and Mass Lost		Washing			
Initial Mass:	469.0	% Moisture:	#DIV/0!	Initial Mass	469.0
Final Mass:	469.0	D10:		Mass of Pan + Soil (B)	888.65
% Mass Lost:	0.0%	D30:		Mass of Pan + Soil (A)	767.02
Tin:		D60:		Mass Passing 200	121.6
Tin + M _D :		C _C :	#DIV/0!		
Tin + M _w :		C _U :	#DIV/0!
